Influence of Water Ingress at the Shield Tunnel Portal on Tunnel Deformation and Load Capacity Weakening

This study focuses on the shield tunnel at Xiangyang Station on Line 3 in Jinan, Shandong Province. Through field measurements, we investigate the deformation patterns of the tunnel and utilize numerical simulations to reveal the characteristics of changes in load capacity, providing valuable insights for similar engineering projects.

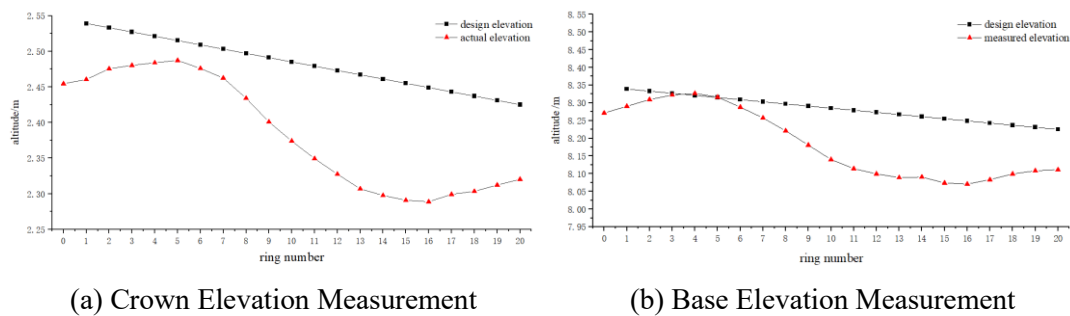
Figure 1. Longitudinal Section Deformation

Following the emergency response, elevation measurements of the tunnel's crown were conducted in the 0-20 ring detection area, with results shown in Figure 1. The measurements revealed that the crown elevations of rings 1-20 experienced settlement compared to the design elevations. The lowest point of settlement was at ring 15, with an actual absolute elevation of 2.2909 m compared to a design elevation of 2.4551 m, representing a relative drop of 164.2 mm. Similarly, the crown elevation also exhibited settlement, with rings 1-3 and 6-20 experiencing reductions. The lowest crown elevation was again at ring 15, measured at 8.0739 m against a design height of 8.2551 m, resulting in a relative decrease of 181.2 mm.

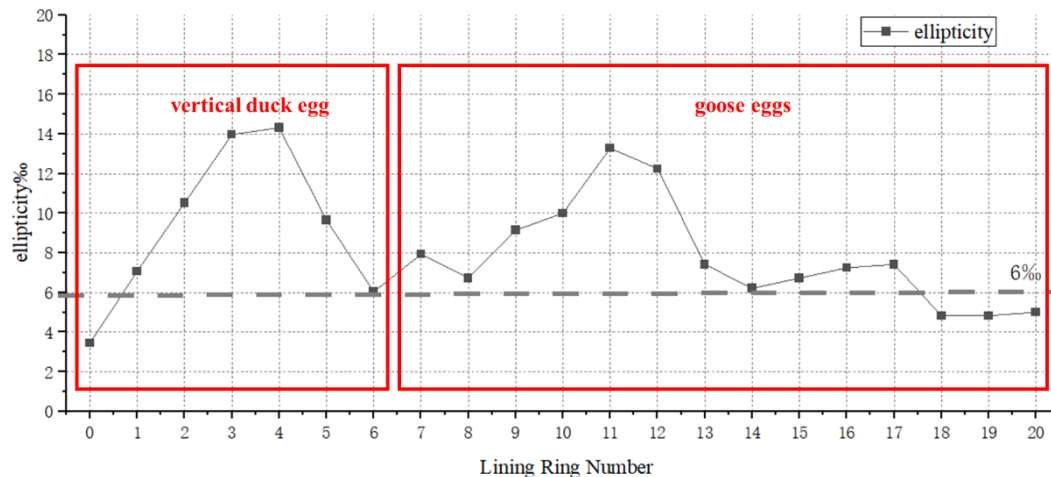
Figure 2. Tunnel Ellipticity

For the 0-20 ring segments, cross-sectional scanning was conducted, with results illustrated in Figure 2. The scan data revealed that rings 0-6 exhibited vertical egg-shaped deformation, with the vertical axis elongated. The maximum deformation reached 4.4 cm at ring 3, and the maximum ellipticity was 14.31% at ring 4. In contrast, rings 7-20 displayed horizontal egg-shaped deformation, with the horizontal axis elongated. Both the maximum deformation and ellipticity for these rings were recorded at ring 11, measuring 4.0 cm and 13.28%, respectively.

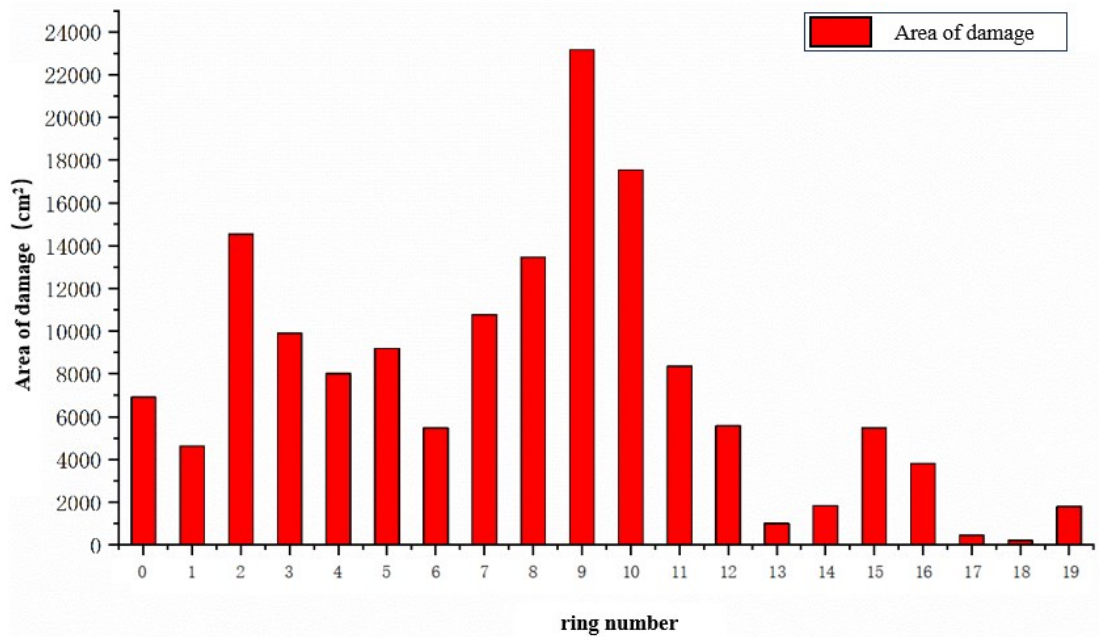
Figure 4. Damage Area Distribution Diagram

All segments in ring 20 displayed damage, with a total of 149 identified instances of damage. The area of damage for each segment is depicted in Figure 4, totaling 15.2095 m². The damage was concentrated at the ring and longitudinal seams, with 91% occurring at the ring seams, often near longitudinal bolts. The largest damaged area measured 140 cm by 50 cm, found at the B2 segment seam of ring 2. Among the 149 instances of damage, 51 were classified as non-delaminated, while 45 were delaminated. Ring 9 exhibited the greatest total damage area, with 18 instances of damage totaling 2.3148 m².

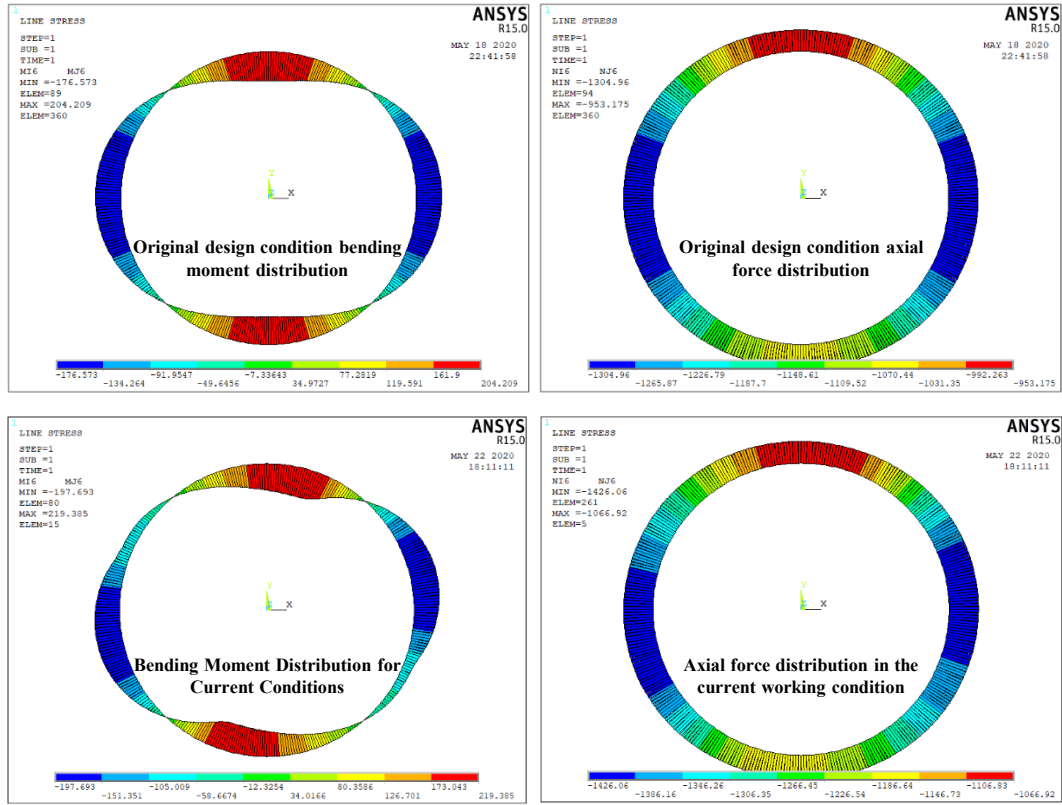
Figure 6. Bending Moment and Axial Force Calculation Results Under Different Conditions

Taking the 8th ring of the left tunnel line as an example, we collected the bending moments and axial forces for each lining ring under both the original design condition and the current condition. From the diagram, it can be observed that, under the original design condition, the maximum positive bending moment occurred in segment B1, with a maximum value of 204 kN·m. The calculated bending capacity at this location is 329 kN·m. The maximum negative bending moment occurred in segment F, with a maximum value of -176 kN·m. The calculated bending capacity at this location is -345 kN·m. The maximum axial force was found in segment B3, with a value of 1304 kN, and the calculated compressive capacity at this location is 8490 kN. The resistance effect ratio R/S was calculated, with the minimum value being 1.61.

Under the current condition, the maximum positive bending moment occurred in segment B1, with a maximum value of 219 kN·m. The calculated bending capacity at this location is 316 kN·m. The maximum negative bending moment occurred in segment F, with a maximum value of -197 kN·m. The calculated bending capacity at this location is -365 kN·m. The maximum axial force was found in segment B3, with a value of 1426 kN, and the calculated compressive capacity at this location is 7980 kN. The resistance effect ratio R/S was calculated, with the minimum value being 1.44.

The comparative analysis shows that the water inflow caused deformation in the tunnel structure, increasing the internal forces. Compared to the original design condition, the bending moment increased by approximately 7%, the axial force increased by approximately 9%, and the minimum resistance effect ratio decreased by about 11%. However, under the current condition, the tunnel still meets the load-bearing capacity requirements.

(2) Numerical simulations were conducted to compare the original design conditions and the current deformed state. The results indicate that after deformation, the internal forces within the tunnel structure increased, leading to an approximate 11% reduction in load-bearing capacity. Despite this reduction, the post-deformation load-bearing capacity still meets the necessary requirements. Reinforcement measures such as installing steel rings or applying carbon fiber plates can be used to further enhance the structure's load-bearing capacity.
