Failure analysis and optimization of coil spring fracture in MacPherson suspension system

Abstract. During a vehicle accelerated corrosion test, a front coil spring in the MacPherson suspension system of an SUV exhibited fracture failure. The results indicated that the material composition, microstructure, and decarburization layer of the coil spring met the technical requirements; however, the tempering hardness was found to be excessively high. Fracture surface analysis revealed a small amount of intergranular cracking in the crack initiation zone, and the crack propagation zone exhibited ductile tearing characteristics, ultimately leading to fatigue fracture. Through force analysis, it was determined that the coil spring was subjected to lateral loads. Additionally, ABAQUS software simulations revealed that during wheel hop conditions, the coil spring end coil came into contact with the spring seat, leading to coating failure and the formation of surface fatigue defects. Based on these findings, an improvement plan was proposed, followed by failure reproduction and optimization validation in a test rig.

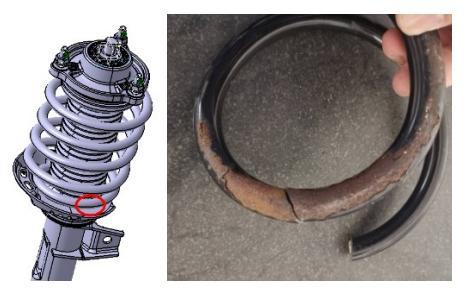
Figure 1. Fractured Coil Spring

In a full-vehicle accelerated corrosion test conducted by an automotive company, the front coil spring fractured at approximately 0.8 turns from the lower end after 57 test cycles, as shown in Figure 1. However, this coil spring had successfully passed the vehicle structural durability test and a 200,000-cycle test at frequencies of 1-6 Hz on a test rig without failure, meeting the required fatigue life standards. To investigate the cause of the failure during the corrosion test, a comprehensive failure analysis was performed, including chemical composition assessment, hardness testing, macro and micro fracture morphology examination, metallographic structure evaluation, and shot peening process inspection.

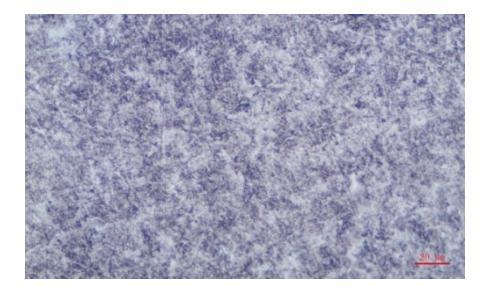
Figure 2. Metallographic Structure (500×)

A sample from the fracture surface was cut and polished following the ASTM E 3-01 standard for metallographic analysis. The microstructure was confirmed to be tempered troostite, which met the required metallurgical specifications, as shown in Figure 2.

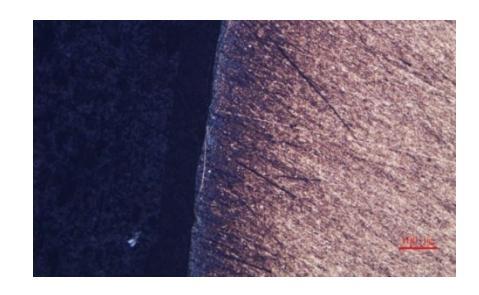
Figure 3. Surface Decarburization Depth (100×)

The decarburization layer depth was measured according to the JIS G0558 standard for steel decarburization measurement. The results confirmed that there was no surface decarburization, as shown in Figure 3.

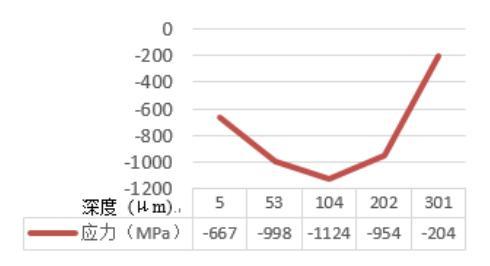
Figure 4. Residual Stress vs. Depth Results

After removing the surface coating, the X-ray diffraction method was used to measure the residual stress of the coil spring. Measurements were taken from the surface to a depth of 0.3 mm, with increments of 0.05 mm, as shown in Figure 4. The surface compressive residual stress was measured at 667 MPa, with the maximum residual stress observed at 104 µm below the surface. The shot peening stress distribution was within the normal range.

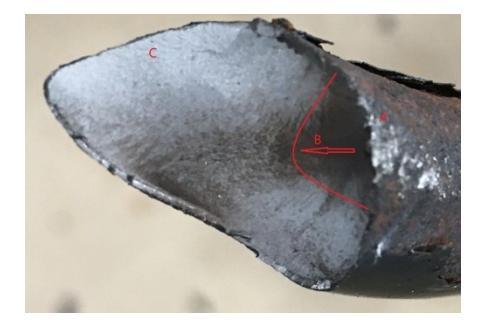
Figure 5. Macroscopic Image of the Fractured Coil Spring

The coil spring fractured at 180° along the contact surface between the first coil and the lower spring seat. In this region, the coating had peeled off, and severe corrosion and rust formation were observed. As shown in Figure 5, the failure zone was divided into three distinct regions: Region A (Contact Area with the Spring Seat): Exhibited a metallic luster, indicating long-term dynamic wear at the contact interface. Region B (Crack Propagation Zone): Displayed reddish-brown rust, which spread radially along the wire diameter due to corrosion testing. The propagation direction suggested that the fatigue crack originated from the lower surface of the coil spring. Region C (Final Fracture Zone): Located at the inner and outer sides of the spring coil, this area was shiny and smooth, characteristic of an instantaneous overload fracture. Based on these observations, the primary failure mechanism was identified as stress corrosion fatigue fracture caused by coating damage.

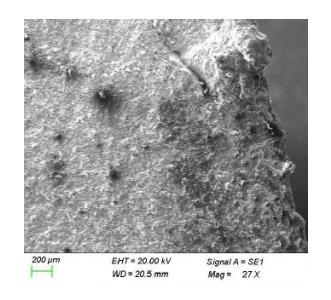
Figure 6. Crack Initiation Zone

(1) Crack Initiation Zone: Due to severe rusting, the precise morphology of the crack origin was not clearly visible (Figure 6).

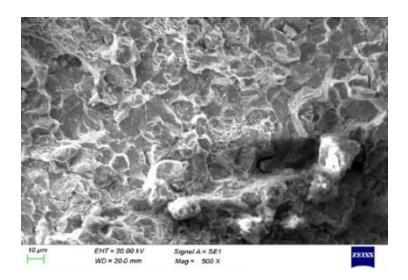
Figure 7. Initial Crack Zone

(2) Initial Crack Zone: A small amount of intergranular cracking was observed, as indicated by the arrows in Figure 7. This was identified as the original fatigue crack initiation site.

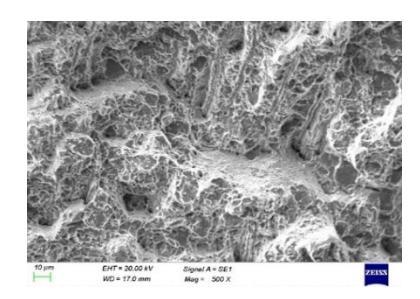
Figure 8. Dimple Features in the Crack Propagation Zone

(3) Crack Propagation Zone: Exhibited ductile dimple features, as shown in Figure 8, indicating that the crack propagation was accompanied by localized plastic deformation. This high-strain zone confirmed that the fracture mechanism was fatigue failure.

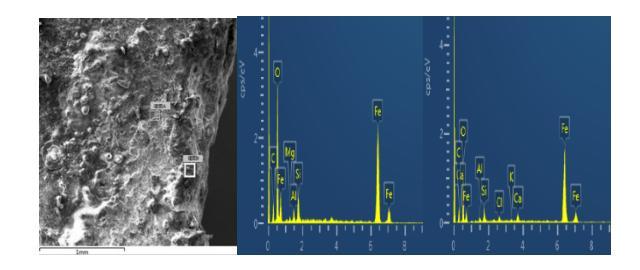
Figure 9. EDS Analysis Results

Energy-dispersive spectroscopy (EDS) was performed on the crack initiation area. Spectral analysis of points A and B, as shown in Figure 9, revealed that the primary component was iron oxide (Fe₂O₃). Additionally, the presence of Mg, K, Ca, and Cl elements suggested contamination from multi-component salts commonly used in corrosion testing.

In summary, microscopic analysis revealed the presence of intergranular cracking at the crack initiation site, indicating that during the vehicle accelerated corrosion test, wear between the spring and the damper seat led to coating damage [6]. This exposed the spring to saltwater corrosion, which penetrated the grain boundaries, weakening the intergranular bonding and forming crack initiation sites [5]. Under cyclic loading, these cracks continued to propagate, eventually resulting in fatigue fracture.

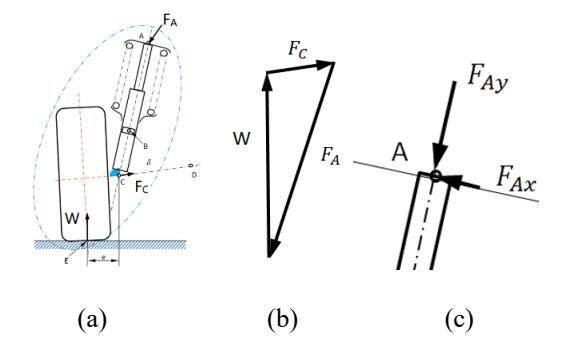
Figure 10. Force Analysis of the MacPherson Suspension Strut

Figure 10 illustrates the force analysis of the MacPherson suspension system, which can be simplified into three forces: W, F_C and FA. FA represents the constraint force exerted by the vehicle body on the upper mount of the damper. W is the reaction force from the ground acting on the tire (excluding the unsprung mass). $F_{\rm C}$ is the constraint force from the lower control arm. Based on the planar force equilibrium theory, the magnitude and direction of F_A can be calculated using W and F_C , as shown in Figure 10(b). F_A can be further decomposed into: F_{Ay} : the force along the spring's axis. F_{Ax} : the force perpendicular to the shock absorber's axis, as shown in Figure 10(c).
