Study on the renovation and reuse strategy of the first batch of high-quality residential communities in China at the end of the 20th century: A case study of Chongqing Jinguoyuan community

Zhaojiang Lv

University of Birmingham, The Vale Reception, Shackleton, Edgbaston Park Road, Birmingham, UK

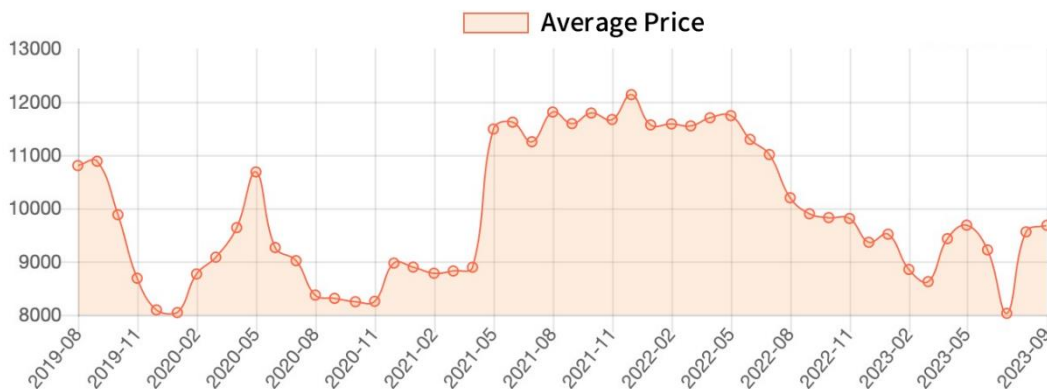
Figure 2. Recent three-year trend price chart of Jinguoyuan Community.

According to housing price data from the internet, although the housing prices in Jinguoyuan Community fluctuate, they have been on a downward trend since May 2022, decreasing by 2.19% compared to other communities in the same area (see figure 2 trend chart of Jinguoyuan's prices over the past three years). There was only a slight increase in September 2023. Undoubtedly, although Jinguoyuan Community was among the latest high-end communities in Chongqing when it was first built, it has now become a mediocre and outdated community.

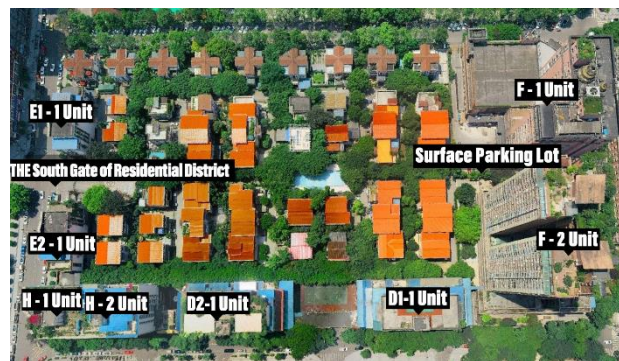
Figure 3. Aerial view, From: https://chongqing.anjuke.com/community/pano/?comm_id=198027&anchor_pano=1

4.1.1. Overall Monotonous Spatial Planning. The planning and layout technique of the community is too monotonous, mainly adopting a row-column layout. The arrangement of the entire community resembles a barracks, with a rigid building arrangement. (See Figure 4) The overall residential group is symmetrically arranged along the central axis, with the main entrance on the south side; a north-south long and east-west short outdoor swimming pool is arranged on the central axis of the community. The overall planning design lacks richness, and the shape of the central pool also lacks aesthetic appeal. (Figure 3:Aerial view below)

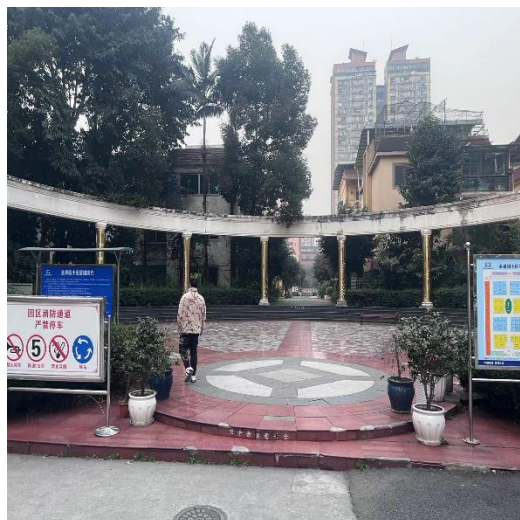
Figure 5. Main entrance of Jinguoyuan Community, photo source: taken by the author.

4.1.3. Waste of Central Swimming Pool Space, Lack of Elderly-Friendly Central Green Space in the Community. At the beginning of the community design, following the spatial configuration of high-end communities, a swimming pool was set up at the central axis. However, research has found that the utilization rate of the pool in this area is very low. Moreover, with the change in the age composition of the community residents, the pool, suitable for young people's use, is completely unfriendly to the elderly's recreational activities. Currently, there are no designs or facilities targeted at the elderly and children within the community, forcing all recreational activities of the residents to take place outside the community. A few activity areas with hard pavement could be set up at the main entrance plaza. (See Figure 5)

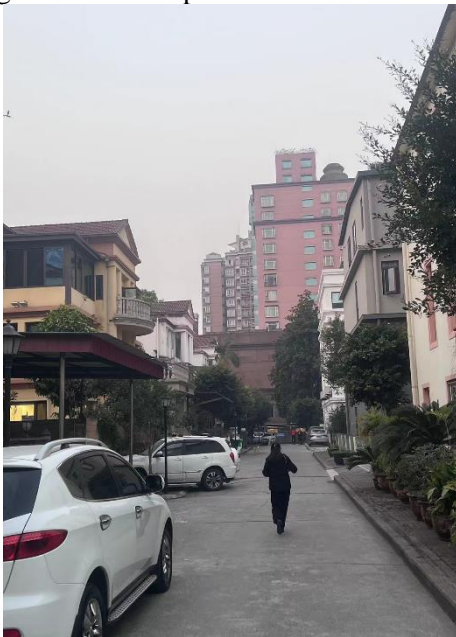
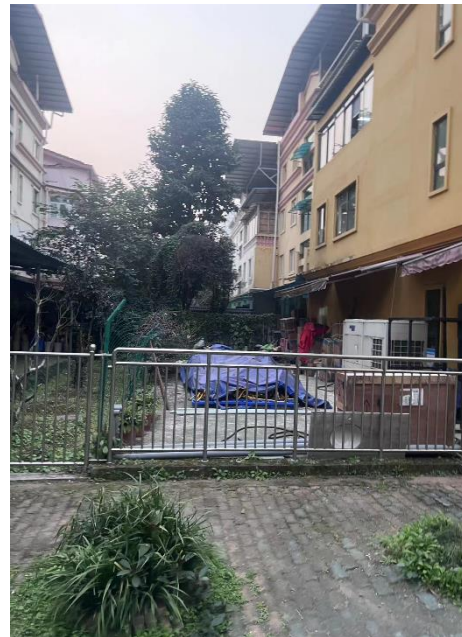
Overall, the landscape design lacks variety in plant species and animals. Most of the greenery in the community consists of potted plants placed in flower pots, with no uniformity in the color, texture of the pots, or types of potted plants. (See Figures 6 and 7) The only tall plants in the community are Yellow Catalpa trees, showing a lack of variety. By the standards of current high-quality residential communities, there should be a design that features “scenery in all seasons” through the use of different plants flowering or remaining evergreen in different seasons. Additionally, while fulfilling the greening requirements, different viewing spots should be set up for seasonal characteristic plants.

Figure 6. The driving passage of Jinguoyuan.
Photo Source: Taken by the author.

Figure 7. The pedestrian walkway of Jinguoyuan.
Photo Source: Taken by the author.

4.3.1. After moving in, most homeowners have personalized their residences through redesign. The transformation of the residential facades has affected the consistency of the community’s architectural style. Villas within the same residential area have even had their windows and walls modified to different colors and styles. (See Figures 6-8)

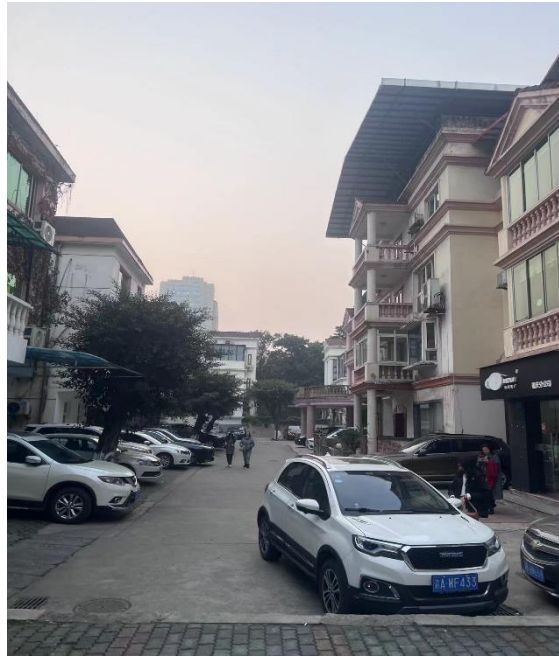
Figure 9. The current situation of disorderly parking in Jinguoyuan Photo Source: Taken by the author.

4.4.1. Insufficient Consideration for Public Parking Spaces. As one of Chongqing's first batches of high-quality residential communities, architects believed at the time that providing two private parking spaces for each villa would be sufficient to meet people's needs, given the number of vehicles owned then. However, twenty years later, the parking arrangement in the community does not meet the needs following China's development over two decades. Currently, there is a severe shortage of parking spaces in the community, with many external vehicles parked along the roadsides, causing congestion (see Figure 9) and affecting normal traffic flow. For residents of high-rise buildings, finding parking within the community has become a significant challenge, resulting in many private cars parked outside the community walls. This poses problems for public transportation and the safety of residents.

Currently, the number of parking spaces within the community is clearly insufficient. To address this issue, the community must plan effectively and gradually expand outdoor temporary parking spaces. Eco-friendly parking space designs can be adopted to alleviate this problem. Eco-friendly parking spaces represent another innovative application of the sponge city concept in the landscape renovation design of older communities. In constructing eco-friendly parking spaces, materials such as permeable turf, grass grids, and grass pavers are utilized instead of concrete. Furthermore, grass and trees are planted around the parking lot to not only provide practical parking functions but also add ecological value (The improvement of parking lot in the effect picture) [8].

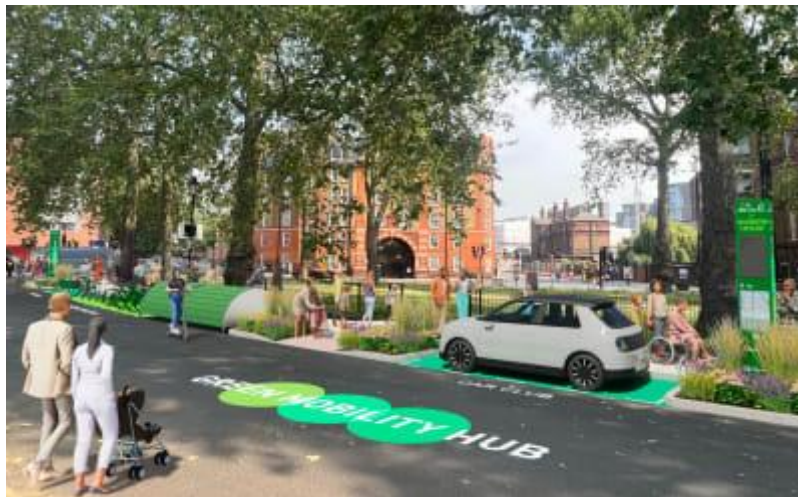
Figure 10. Effect Picture, From: https://www.google.com/url?sa=i&url=https%3A%2F%2Fstowndfn2030.commonplace.is%2F&psig=AOvVaw15VpR-yVkViCDc_7L-mUJv&ust=1706481361538000&source=images&cd=vfe&opi=89978449&ved=0CBAQjRxqFwoTCNiktc7Q_oMDFQAAAAAdAAAAABAD

By refurbishing and redesigning the plant landscape, the quality of public activity spaces within the community can be improved. Many of the roads within the community are spacious enough to facilitate the separation of pedestrians and vehicles. Some areas with varied topography can be landscaped appropriately to enhance the attractiveness of the community. (see Figure 10) With the support of the homeowners, green vegetation or green spaces suitable for the rest and activities of the elderly and children can be added within the community. Additionally, a small portion of the land can be jointly managed with the homeowners, allowing them to plant vegetation or trees, with quarterly evaluations determining reduced property fees for the best-maintained areas. This approach encourages a sense of belonging among the homeowners and involves them in the improvement of the community. Before undertaking renovations to the community's roads and greenery, extensive input from homeowners regarding their preferences and needs should be solicited to ensure that their spatial requirements are progressively realized within the community.
