Influence of Water Ingress at the Shield Tunnel Portal on Tunnel Deformation and Load Capacity Weakening

This study focuses on the shield tunnel at Xiangyang Station on Line 3 in Jinan, Shandong Province. Through field measurements, we investigate the deformation patterns of the tunnel and utilize numerical simulations to reveal the characteristics of changes in load capacity, providing valuable insights for similar engineering projects.

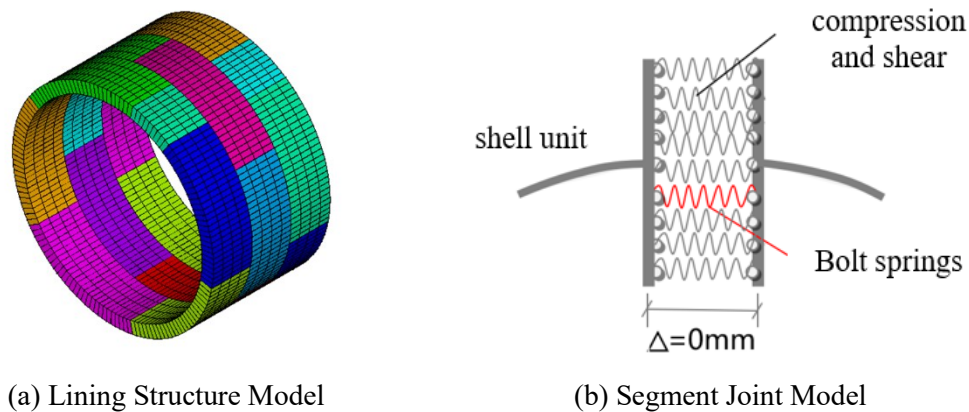
Figure 5. Model Diagram

The current condition analysis uses a shell-spring model, which was established using the ANSYS software. The model schematic is shown in Figure 7. The lining structure was created based on the actual design dimensions: a ring width of 1.2 m, segment thickness of 0.35 m, and a calculated radius of 2.925 m. The segmentation and assembly angles were kept identical to the actual structure, including one crown segment (F, 20°), two adjacent segments (L, 68.75°), and three standard segments (B, 67.5°). Nonlinear shell elements were used to simulate the segments. The longitudinal and circumferential joints were simulated with spring elements, accounting for the concrete compression, radial and longitudinal shear effects at the joint locations, and the nonlinear behavior of the bolts, as shown in Figure 5(b).
