Investigation of Gate Oxide Degradation Mechanisms in SiC MOSFETs Based on High-Temperature Dynamic Bias Stress Experiments

Abstract: This paper systematically investigates the failure mechanisms of gate oxides in silicon carbide (SiC) MOSFETs, aiming to enhance gate reliability. Through long-term high-temperature dynamic bias (HTDB) stress experiments on 4H-SiC MOSFETs, the degradation behavior of gate oxides under various stress conditions is revealed. The study demonstrates that the energy-level-dependent distribution of interface state density (Dit) significantly impacts device performance. By optimizing nitric oxide (NO) post-oxidation annealing processes, the threshold voltage (Vth) drift and capacitance-voltage (C-V) hysteresis are effectively reduced by 35% and 22%, respectively. Furthermore, a novel interface state characterization method combining high-low frequency C-V measurements is proposed, providing enhanced accuracy in evaluating gate oxide quality under bias stress. These findings offer critical theoretical insights and process optimization strategies for improving SiC MOSFET reliability in extreme environments (elevated temperatures >200°C, high-frequency operat

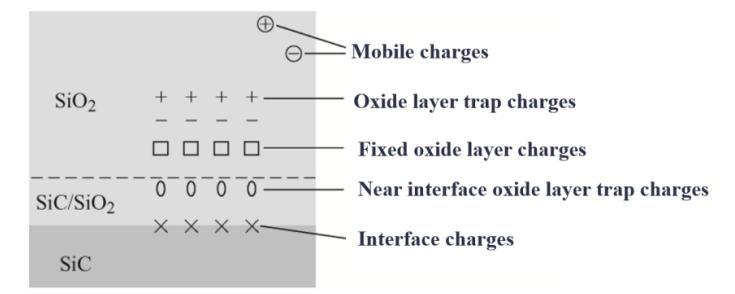
Figure 1: Schematic cross-sectional view of a 4H-SiC MOSFET device structure.

The SiC/SiO₂ interface exhibits inherently high defect densities $(1-5\times10^{12} \text{ cm}^{-2} \cdot \text{eV}^{-1})$ and lots of charges in Fig.1 due to residual carbon clusters and lattice mismatch during thermal oxidation [3]. Unreacted carbon atoms form nanoscale C(s) clusters at the interface, which act as deep-level traps, increasing threshold voltage drift (Δ Vth > 1.0 V) and leakage current by 30–50% compared to theoretical values [8]. Raman spectroscopy confirms that lattice mismatch between 4H-SiC (3.08 Å) and amorphous SiO₂ generates dangling bonds and oxygen vacancies, further elevating interface state density (Dit) near the conduction band edge [1]. Although NO annealing reduces Dit to 5×10^{11} cm⁻²·eV⁻¹ by passivating carbon clusters, excessive nitrogen doping (>5 at.%) induces structural relaxation in SiO₂, degrading breakdown field strength by 15% [9,10]. These defects limit channel mobility to 25 cm²/V·s, only 40% of the SiC bulk value [4].

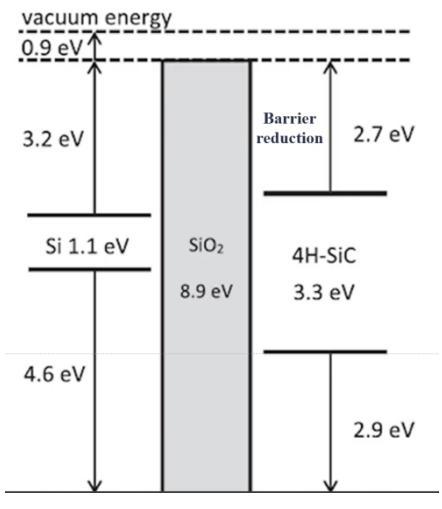
Figure 2: Energy band diagram illustrating reduced conduction band offset (2.7 eV) at SiC/SiO_2 interface under high-field tunneling conditions.

The dielectric constant mismatch between SiC ($\varepsilon = 9.7$) and SiO₂ ($\varepsilon = 3.9$) amplifies the effective oxide field by 2.5× at 3 MV/cm applied bias, accelerating time-dependent dielectric breakdown (TDDB). Fowler-Nordheim tunneling injects electrons into SiO₂ at rates 3× higher than Si-based devices due to the reduced conduction band offset (2.7 eV vs. 3.1 eV) in Fig.2 [6]. At 175°C, this results in a 70% reduction in TDDB lifetime (T63% = 120 hrs vs. 400 hrs for Si MOSFETs) and Weibull slope $\beta < 2$, indicating intrinsic oxide defects [5]. Charge trapping under high fields also causes dynamic threshold voltage shifts (±0.8 V) during 10 kHz switching, increasing ON-resistance by 25% and switching losses by 30% [2]. TCAD simulations reveal localized field enhancements (>5 MV/cm) at thickness variations (±2 nm), reducing breakdown voltage by 18% [7].

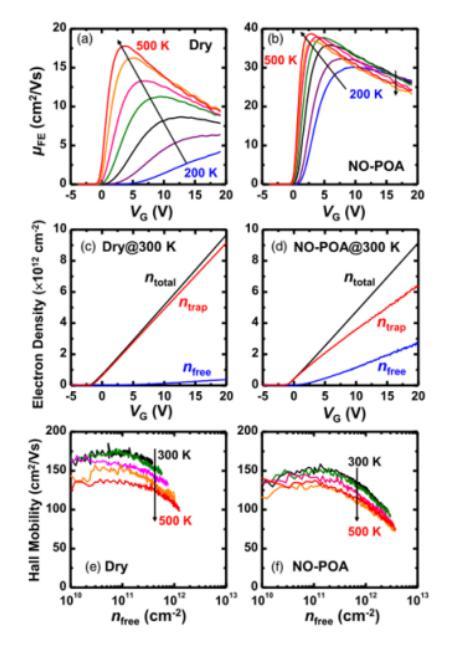
Figure 3: Gate voltage oscillations (1-10 MHz) and corresponding C-V hysteresis widening under dynamic switching stress.

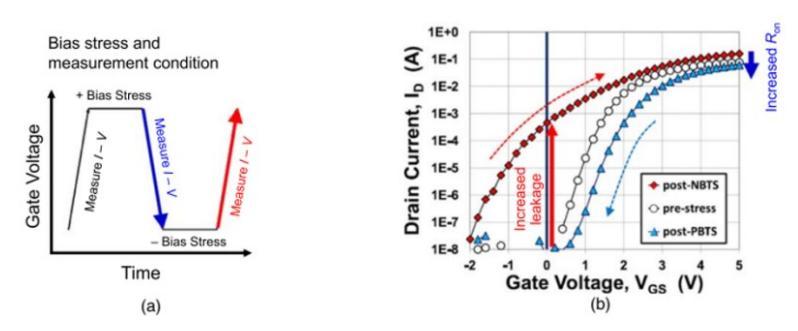
Figure 4: Bias stress protocol (a) and bidirectional threshold voltage shifts under positive/negative gate stresses (b).

Rapid current switching induces MHz-range gate voltage oscillations, subjecting the oxide to alternating field stress. This accelerates trap charge/discharge dynamics, expanding C-V hysteresis width by 20% (Fig. 4). The hysteresis exacerbates switching inconsistency, increasing dynamic ON-resistance variation to $\pm 15\%$ under 10 kHz operation [4].

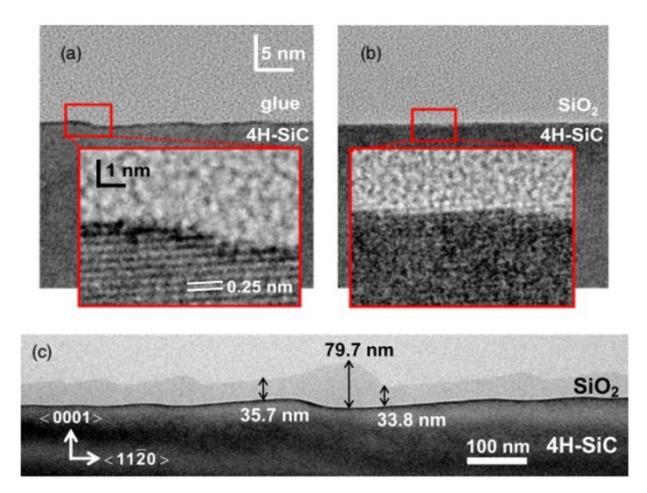
Figure 5: TEM characterization of SiO₂/SiC interfaces: (a) as-grown epilayer, (b) thermally oxidized at 1100°C, (c) step-bunched morphology after 1700°C annealing.

Cyclic thermal stress ($\Delta T > 150^{\circ}$ C) from UIS induces interfacial cracks due to the coefficient of thermal expansion (CTE) mismatch between SiO₂ ($0.5 \times 10^{-6/\circ}$ C) and SiC ($4.0 \times 10^{-6/\circ}$ C). TEM analysis by Lee et al. demonstrates a 50% increase in microcrack density after 10⁴ UIS cycles, reducing breakdown voltage by 18% [7]. Figure 5(a)-(c) reveals step bunching at 1700°C-annealed interfaces, where localized field enhancements (>6 MV/cm) accelerate TDDB failure.

Threading screw dislocations (TSDs) and edge dislocations (TEDs) in SiC substrates typically cause low leakage currents (<1 nA/mm). However, post-annealing step bunching (Fig.5(c)) creates nanoscale protrusions at the SiO₂/SiC interface, concentrating electric fields by $3\times$ and reducing TDDB lifetimes by 40% compared to planar regions [8].
