Monitoring of Ground Deformation in Mining Region Based on Time-series InSAR

Abstract: Tailings ponds, essential for mining operations yet potential geological hazards, require rigorous safety monitoring. Conventional ground deformation methods are inadequate for contemporary precision and spatial coverage standards. InSAR technology, offering millimeter-level accuracy and robust spatio-temporal continuity, has become vital for monitoring deformation in mining areas. This study examines InSAR-based monitoring of ground deformation at the Baizhangzi Gold Mine's tailings pond and collapse zone in Lingyuan, Liaoning, China. Utilizing SBAS-InSAR, this study processes SAR image data for comprehensive analysis. Findings indicate that while the tailings pond remains stable, the collapse zone experiences significant subsidence, primarily attributed to anthropogenic mining activities. The results demonstrate that SBAS-InSAR is effective for monitoring subsidence in mining regions, contributing to geological hazard mitigation and serving as a reference for analogous mining sites.

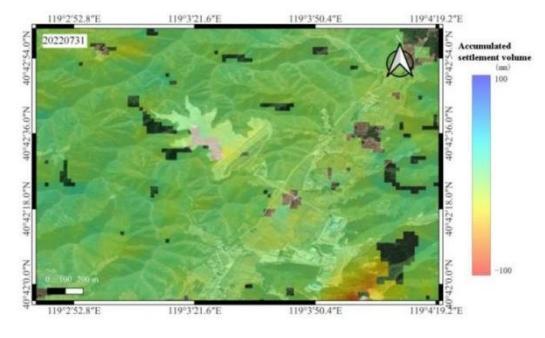
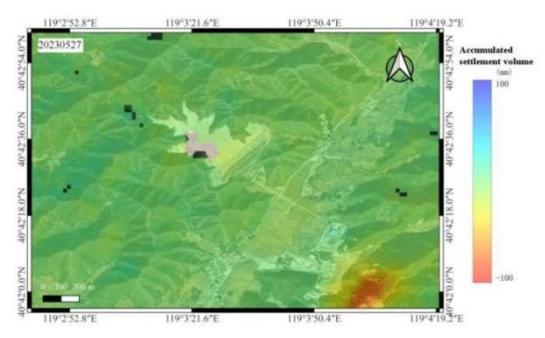
Figure 1: Data of tailings pond dry beach (group 1, 2022.1.8~2022.7.31)

Figure 2: Data of tailings pond dry beach (group 2, 2022.11.4~2023.5.27)

Analysis of InSAR data (Figure1&2) reveals minor subsidence (-10mm) around the tailings pond dry beach, except for significant displacement in the SE region. The central subsidence zone shows progressive deformation from minimal to severe, with maximum vertical displacements of -100mm and -75mm in the respective monitoring periods. Both displacement patterns exhibit NE-trending deformation, with peripheral areas showing negligible subsidence (-10mm), indicating stable conditions.

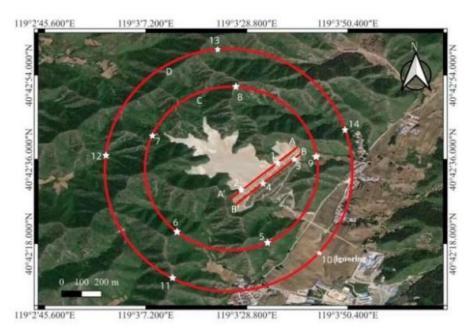
Figure 3: Feature point selection of the tailings pond and its surrounding areas

To conduct a more detailed study on the subsidence in the area surrounding the tailings pond, points were selected on the satellite images of the tailings pond. Two parallel profiles (AA', BB') were established on the dam, and in Figure 4, the equidistant sampling points on them were marked by squares and rhombuses, respectively. Concentric circles C and D were drawn around the dry-beach area, with points 5-9 (triangular markers) and 11-14 (circular markers) sampled at equal angular intervals. Point 10 was excluded due to agricultural interference. Cumulative subsidence was calculated for both measurement groups.

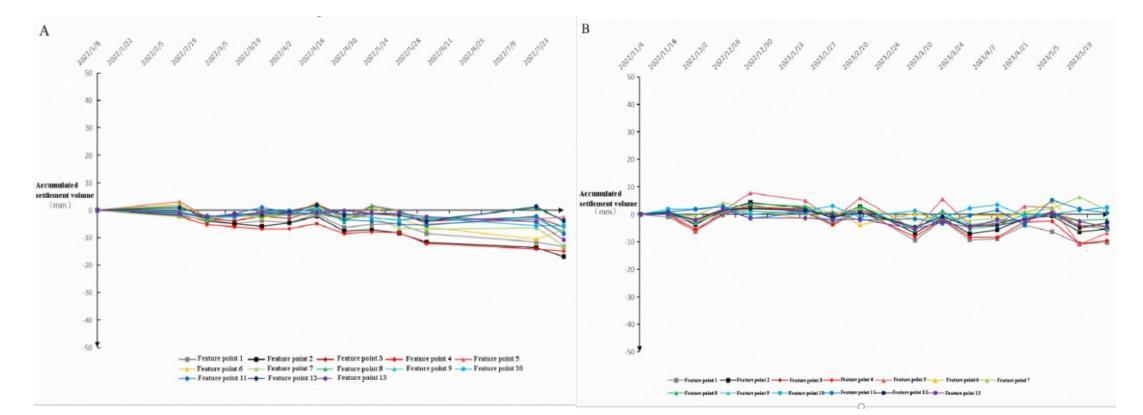
Figure 4: Subsidence analysis of the tailings pond and its surrounding areas. Fig. A shows the first set of data, and Fig. B shows the second set of data

Based on subsidence data, both periods show minimal settlement: Group 1 ranges from +5 to - 20mm, Group 2 from +10 to -15mm. Some points exhibit uplift rather than settlement, likely due to

measurement noise. Overall, tailings pond subsidence is minimal. Points 1, 2, and 4 on the dam exhibit accelerated settlement rates, suggesting minor dam deformation. Points 7 and 11 showed increased subsidence during the Nov 2022- May 2023 monitoring period (Figure 4).

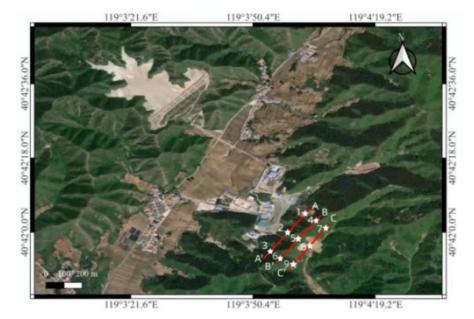
Figure 5: Feature point selection of the collapse region and surrounding areas

Three parallel transects (Figure 5) were established across the collapse zone using satellite imagery and SAR data. Nine monitoring points were selected equidistantly along these transects to measure subsidence. Points 1-3 are marked with circles, 4-6 with rhombuses, and 7-9 with squares. The cumulative subsidence data from the first two monitoring periods follows.

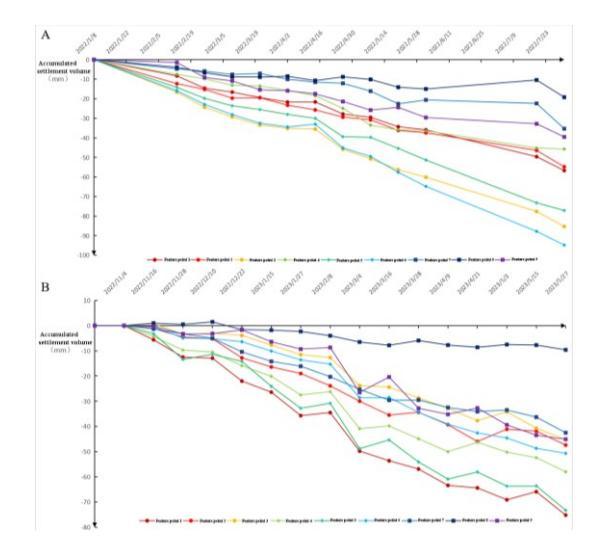
Figure 6: Subsidence analysis of the collapse region and surrounding areas; Fig. A shows the first set of data, and Fig. B shows the second set of data

Statistical analysis (Figure 6) reveals continuous subsidence across all 9 monitoring points, with cumulative displacement of -20 to -100mm and -10 to -80mm over two periods. Maximum subsidence occurred along profiles AA' and BB', while Point 8 showed minimal displacement. Topographic

gradient analysis from AA' to CC' indicates occasional upward displacement at lower elevations, attributable to either debris accumulation or measurement noise.

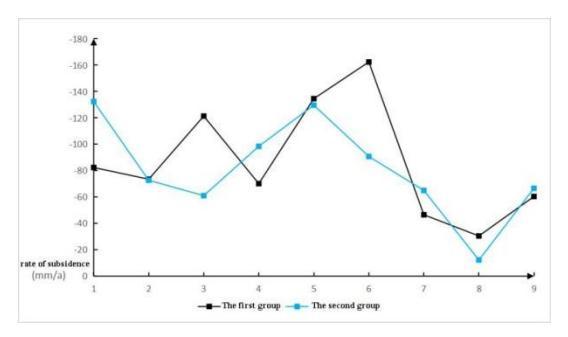
Figure 7: Subsidence rate statistics of two groups of feature points in the subsidence area

Surface subsidence rates vary across the collapse zone, with Point 6 exhibiting maximum velocity at -162 mm/a (Jan- Jul 2022), while Point 8 shows minimal displacement (Figure 7).

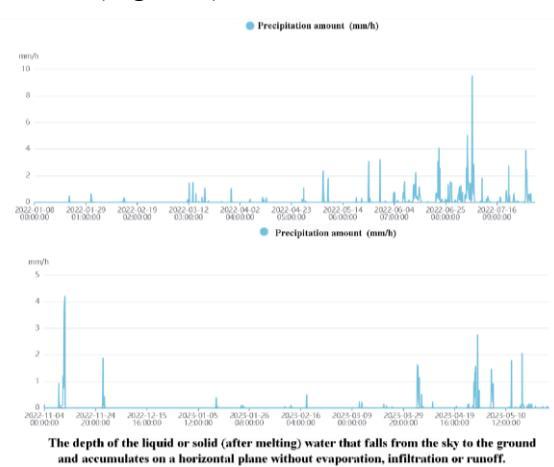
Figure 8: Precipitation of the mining region; Fig. A shows the data from January 8, 2022, to July 31, 2022, and Fig. B shows the data from November 4, 2022, to May 27, 2023

The Baizhangzi Gold Mine site, situated in southwest Liaohe Plain (<50m elevation), experiences temperate continental monsoon conditions. NASA data indicates significant precipitation variability during the monitoring period. Both natural factors and anthropogenic activities contribute to the observed land subsidence patterns (Figure 8).
