Analysis of fire risk and fire prevention of architectural heritage: A case study of mount wutai in China

Siming Li

University College London, London, N1 6FS, United Kingdom

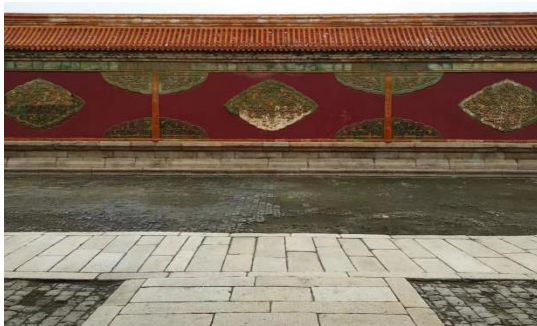
Figure 1. Corroded wooden wall (Photo credit: the author).

The buildings of Mount Wutai are mainly temples with a long history. The earliest temples were built in Tang Dynasty, Song Dynasty, Yuan Dynasty, Ming Dynasty, and Qing Dynasty. The low fire-resistant wood materials and the building structure of Mount Wutai temples are the main reasons for the high occurrence of fires in ancient buildings. As shown in Figure 1, the temple of Mount Wutai is mainly composed of the wood structure and brick-wood structure, and the main building materials are pine and nanmu rich in oil. With the wind and sun for hundreds of years or even thousands of years, the wood of historical buildings of Mount Wutai has been dried, and the water content in the wood is very low. Once a fire occurs, the turpentine will immediately become a combustion-supporting substance, and the fire resistance is extremely poor. The low fire resistance rating also leads to a sharp increase in the probability of fire accidents in hot summer [7]. At the same time, there are many cracks and splicing gaps in the wood of the temple, and most of the ventilation conditions are good. The annual wind of Mount Wutai is 5-6, so the fire spreads quickly. In addition, there are many inflammable hangings such as decorations and curtains in the temple. They will become a risk factor for the vertical spread of the fire, which can quickly expand into the air to form a three-dimensional fire. Moreover, the group layout of the wooden structure is not conducive to evacuation. As seen in Figure 2, many of the structures of cultural relics and ancient buildings in Mount Wutai have high roofs and airtight interior structures, which provide good conditions for burning and flame spreading. Once a fire occurs, the temples will not be able to discharge the internal heat and smoke in time, resulting in rising indoor temperature, which is easy to reach "flameout" and leads to collapse. This is also the main reason for the large-scale burning of cultural relics and historical buildings [8].

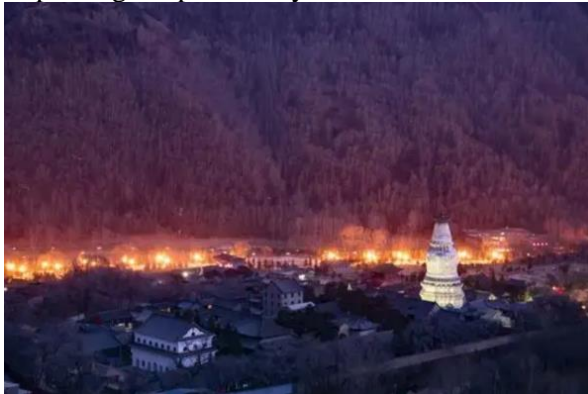
Figure 3. Temples surrounded by trees that caused an uncontrollable fire [10].

In addition, the natural geographical characteristics of ancient buildings in Mount Wutai are also factors that need to be paid attention to. As exhibited in Figure 3, Mount Wutai scenic area has a high forest vegetation coverage rate. Ancient building groups depend on the mountain, and the geographical location is relatively complex. The natural geographical fire risk of ancient buildings in Mount Wutai is mainly the small fire spacing of historical buildings and the lack of fire water source. First of all, temples of the Mount Wutai are located in density, the fire spacing between the buildings did not meet the safety requirements, and even some buildings are completely connected. There is no fire access in line with the code. Once there is a fire, other ancient buildings around will inevitably involved [9]. Taking the Five Ye Temple as an example, there are bell towers, drum towers, side halls, guest rooms on both sides of the main hall, and the fire can spread rapidly along the horizontal and vertical directions. At the same time, if the building lightning protection measures are not in place, the temple may become the object of lightning strikes, which will also lead to the occurrence of fire. Secondly,

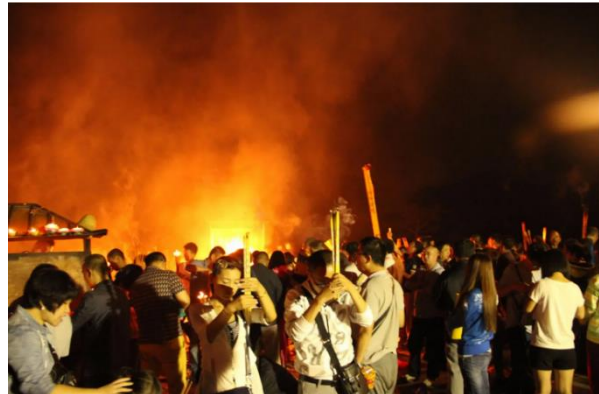
Figure 4. Overburned incense (Photo credit: the author).

As shown in Figure 4, for one thing, with the rapid development of tourism, Mount Wutai temple has become a focus of tourists from all over the world to visit and pay homage to Buddha. The number of resident monks and nuns in the scenic spot reaches more than 5,000 in the peak season, and the annual number of tourists reaches more than 5.8 million, which is greater than its actual capacity [14].

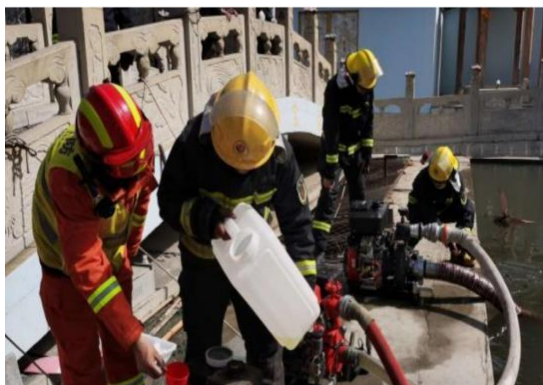
Figure 5. The water pumping system [12].

Second, it is important to equip fire extinguishers according to the design specifications, set up fire hose reels, water pump systems, and lightweight fire hoses as seen in Figure 5, and build rainwater tanks if conditions permit.

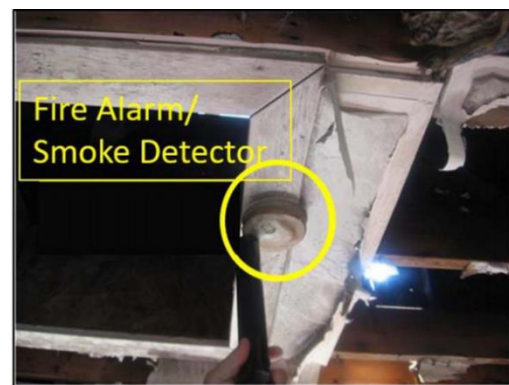
Figure 6. The fire alarm/smoke detector [12].

Third, it is necessary to set up a proper fire alarm system as demonstrated in Figure 6. Smoke, temperature, and flame detectors have a certain installation height, two to three detectors can be used in combination, and video monitoring systems can be used to set up remote monitoring platforms using Internet of Things (IoT) technology to ensure the alarm effect of the fire alarm system [18].

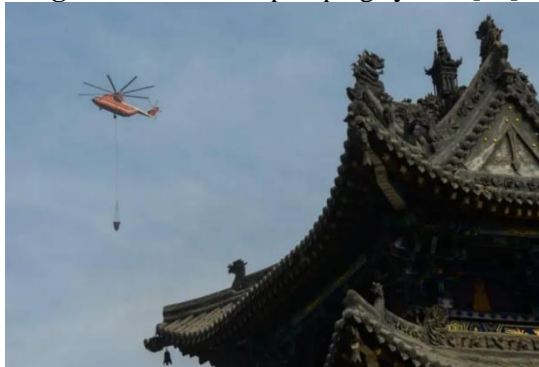
Figure 7. Compressed air foam aircraft fire extinguishing bombs [13].

What is more, there is also a need to strengthen the construction of public facilities, for instance, fire extinguishing bombs (Figure 7), fire extinguishing guns (Figure 8), and fire extinguishing agents. Besides, the roads in Mount Wutai Scenic Area are supposed to be repaired to meet the requirements of fire vehicles [19].
